## **Roslindale Village walk assessment report**

On Saturday, December 5, 2015, the recently formed WalkUP Roslindale community advocacy group conducted a walk audit in Roslindale Square in order to assess walking conditions and to develop a list of recommendations to present to group members, supporters and ultimately the Boston Transportation Department.

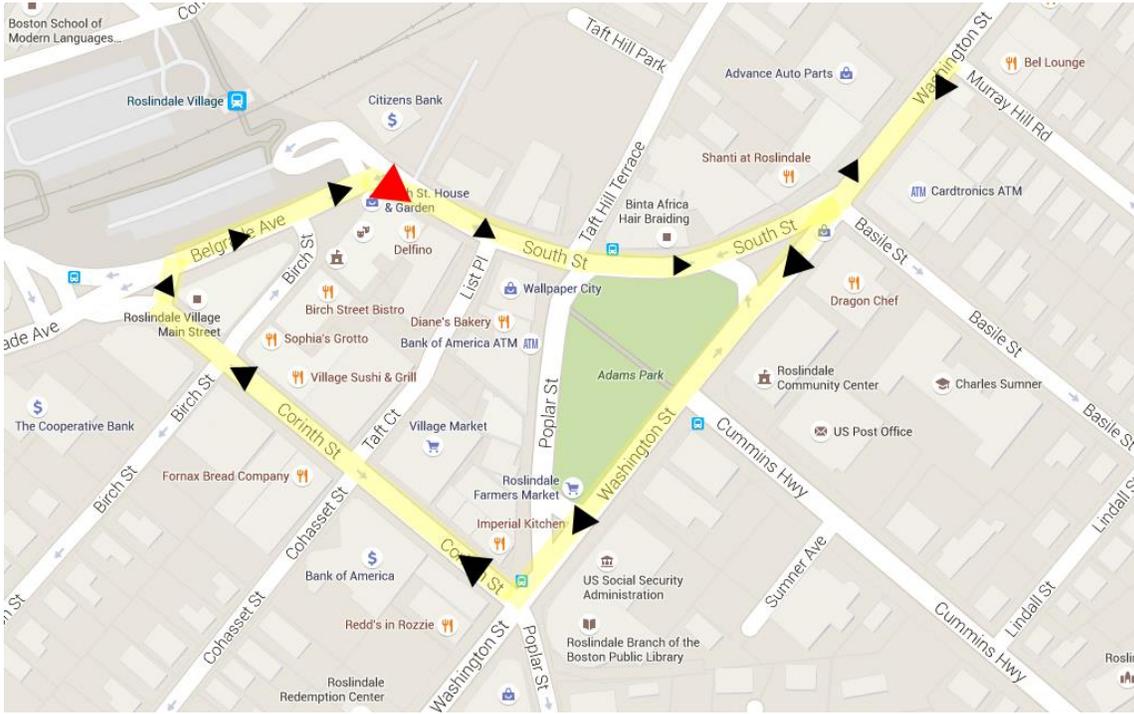
*Figure 1: December 5, 2015 walk audit route*

WalkBoston joined twenty-five WalkUP Roslindale supporters to conduct the walk audit. (The route is presented in Figures 1 and 2.) Evidence of the Square's revitalization in the past two decades was obvious to the participants, who are listed in Appendix A. They noted an active street life with many folks walking or bicycling on their way to visit shops, restaurants, bakeries and markets. The area residents' commitment to supporting locally owned shops and businesses has contributed to a vibrant local economy and is indicative of the neighborhood's strong local identity.

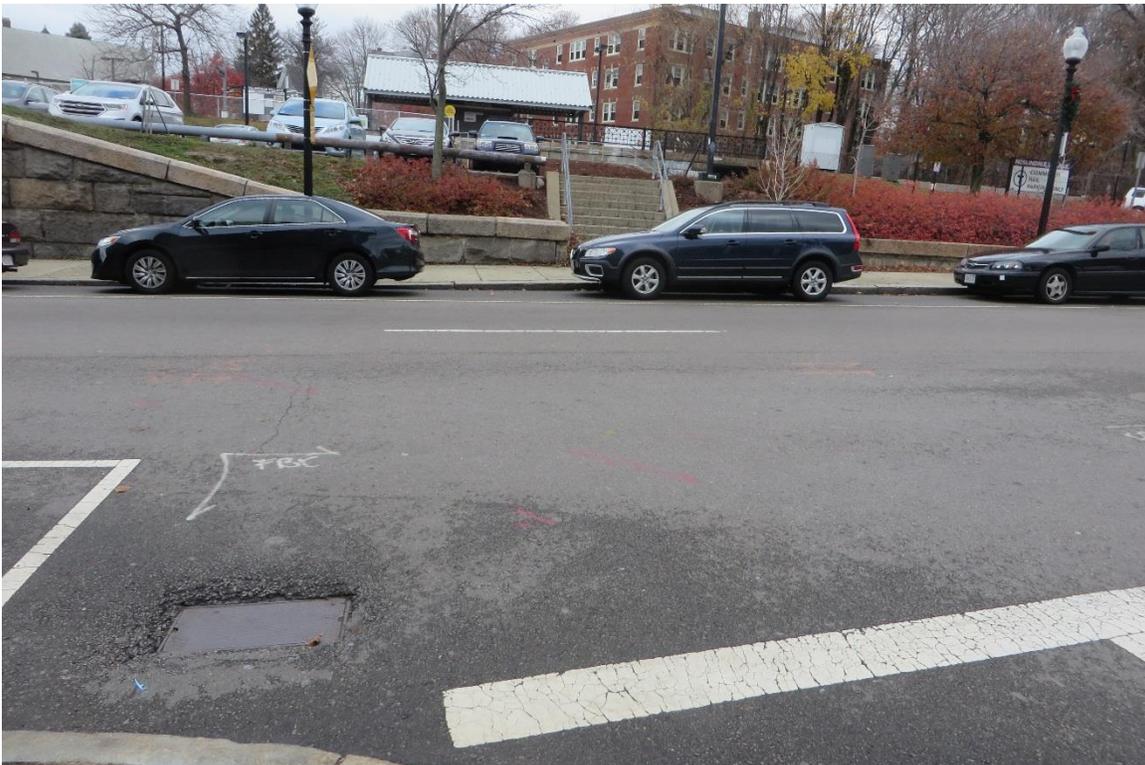
There is a strong pedestrian desire line (preferred path of travel) across Belgrade Avenue, mid-block, to and from the commuter rail station. However, as shown in the photo there is no crosswalk to the Station.

*The steps at the Commuter Rail Station do not connect to a pedestrian crossing on Belgrade Avenue.*

A safe crossing to the steps needs to be developed and installed. Because vehicle volumes on this stretch of Belgrade were quite low all three times the WalkBoston team assessed this area, we think that a raised crosswalk from Belgrade to the commuter rail stairs would provide a safe crossing. Installing a pedestrian-actuated WALK signal here that would be coordinated with the signal at South Street/Citizen's Bank would further enhance safety.

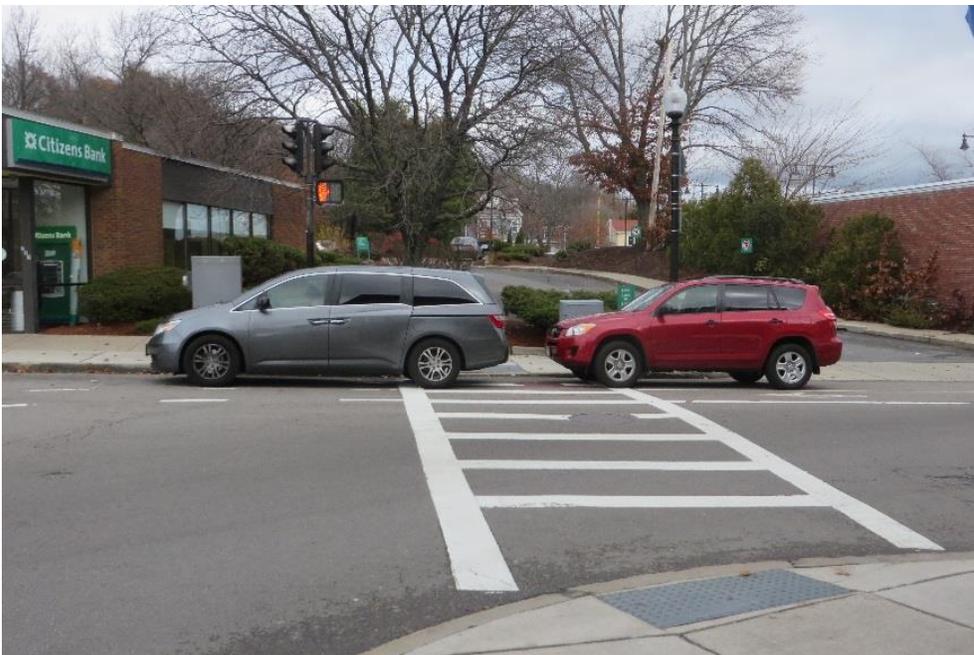
This is a major pedestrian crossing, especially on Saturdays when the Square draws many shoppers to the Farmers Market. There is a crosswalk at this location, but often cars do not stop for pedestrians. And twice when WalkBoston visited the Square cars were parked in the crosswalk. Other times cars were parked right up to the crosswalk, not observing the rule that cars be parked 20 feet from the crosswalk. We recommend NO PARKING be painted in bold letters on the street and that perhaps flex post bollards should be placed on both sides of the crosswalk to keep parked cars away from the intersection to improve visibility. These would be short-term measures. A longer-term solution would be a raised crosswalk and curb extensions so walkers would be more visible to drivers.

*Cars parked in the crosswalk at South Street and Belgrade Avenue obstruct pedestrians.*

This intersection's signals for cars were also judged to be small and antiquated. For example, they are dim much of the time. They should be replaced with larger and more visible signals. In addition this signal could be coordinated with a new mid-block crossing on Belgrade to the commuter rail station.

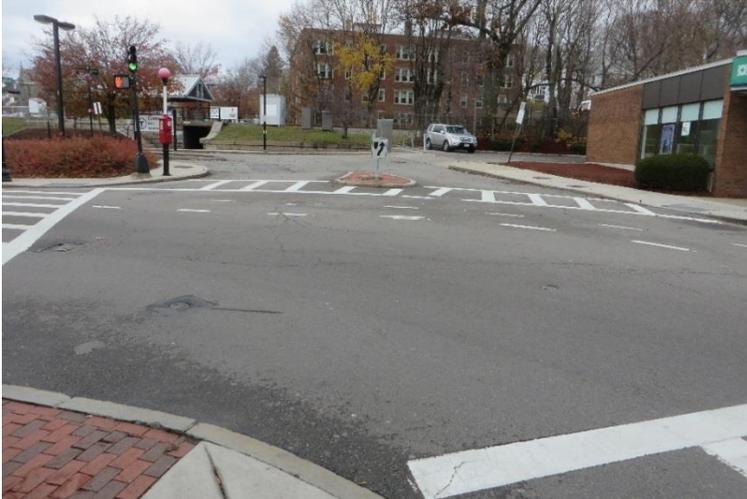
The traffic signals are placed off to the side of the street here so that many drivers seem to be unaware of these signals. Walk audit participants suggested that the traffic signal could be shifted to the currently empty concrete island at the entrance to the commuter rail parking lot to enhance its visibility (see photo below).

*The traffic signal at the corner of South Street and Belgrade Avenue (top left of picture) is difficult for oncoming drivers to see and might be shifted to the concrete island (top center of picture) to enhance its visibility.*

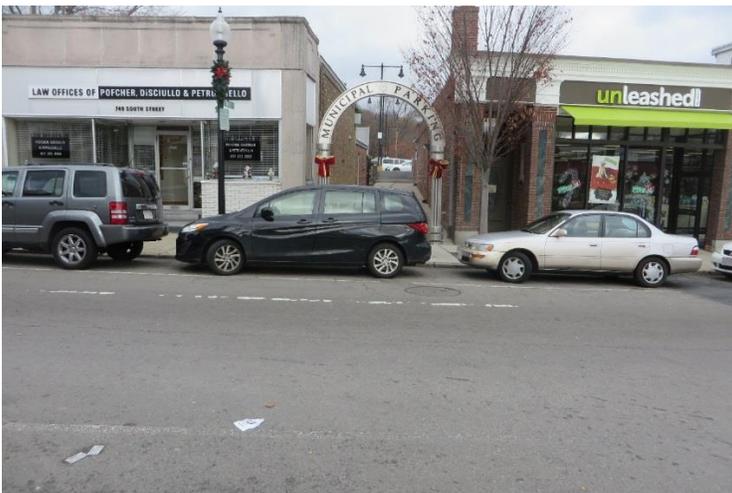
The graciously designed arched gate is the entry point to the Taft Hill neighborhood, as well as to a large parking lot and a potential development site. However there is no crosswalk here. This crossing is only half a block east from the Citizen's Bank and another raised crossing at this location would slow traffic on this block of South Street considerably. To explore this alternative, WalkUP Roslindale can consult with the city's traffic engineers as to whether moving the existing Citizen's Bank crosswalk to or nearer to this point would be helpful.

*There is no crosswalk across South Street to connect the Taft Hill parking area and community to Roslindale Square.*

When a crosswalk is installed at this location, parking in front of the arched gate would be prohibited. To enhance the visibility of pedestrians waiting to cross the street, curb extensions could be added upon which bicycle parking and maps could be placed.

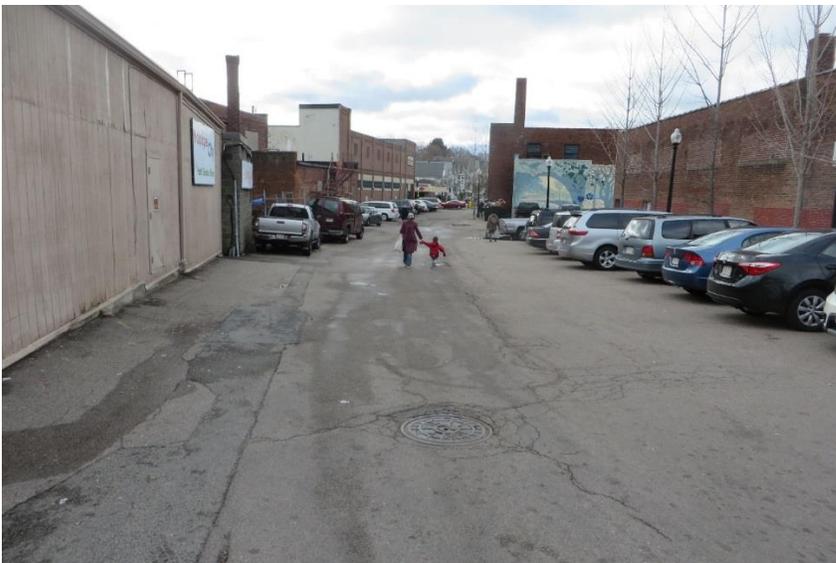
There is a large private parking lot on Taft Court/List Place. While there is a sidewalk on the west edge of the lot, it is very narrow; most people walk down the center of the parking lot. Either a broader sidewalk or a clearly marked pedestrian path would be a big safety boost. The parking lot is privately owned so improved pedestrian circulation measures would need to be accepted by the property owner. Given the strong community spirit in the neighborhood and the active Main Street Program, we suggest approaching the owner and making the case for cost-effective pedestrian safety improvements.

The most critical safety improvement should be ensuring the one-way vehicle circulation through design elements. Vehicles are supposed to enter on Corinth Street and exit on South Street. However, an overly wide opening at South Street invites cars to enter there, creating conflicts with exiting vehicles. Occasionally, the entering/exiting vehicles create so much congestion that cars back up onto the Corinth Street sidewalk, endangering walkers.

*The private parking lot between South and Corinth Streets (Taft Court/List Place) lacks adequate pedestrian accommodations.*

- a. Improve the entrance to Sophia's Grotto restaurant from the parking lot by adding sidewalks and/or relocating the dumpsters.
- b. Make the sidewalk at the South Street driveway the same material as the adjacent sidewalk to send a visual signal to drivers that pedestrians have the right of way along the sidewalk. (The adjacent sidewalk is brick and the sidewalk at the driveway entrance is concrete.)
- c. Paint murals along the buildings facing the parking area and access lane.

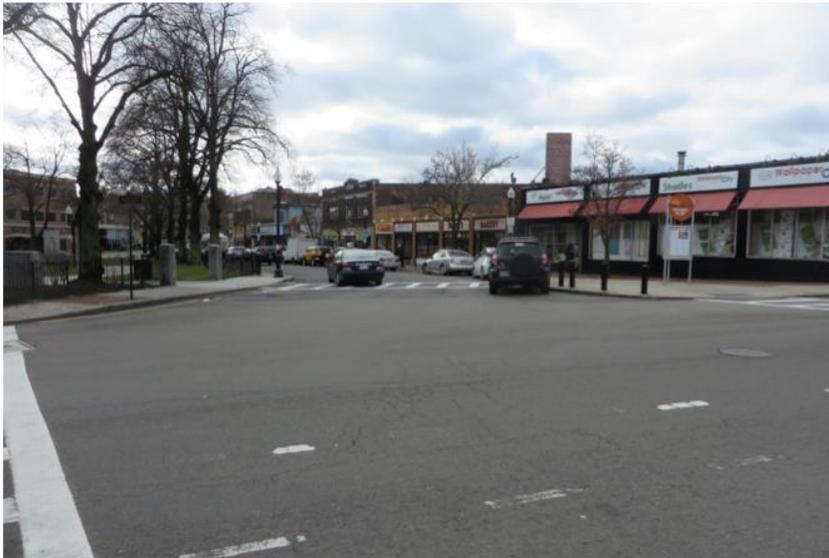
This intersection creates a difficult crossing to Adams Park, as the current crosswalk across South Street ends in the curb to the right of the existing curb ramp. In addition, the unnecessarily large amount of pavement and wide turning radius at Poplar Street encourage drivers to speed up, and the breadth of the roadway requires crossing pedestrians to cover an unnecessarily long distance during brief breaks in vehicle traffic.

*The intersection of South Street and Poplar Street has more pavement than needed and a wide turning radius, which both contribute to high traffic speeds.*

Our recommendation is that, eventually, the intersection should be re-designed once a decision is made whether to convert the streets around Adams Park from one-way to two-way. In the interim, the curb on the southwest corner (adjacent to Wallpaper City) should be extended into the street using paint, flex posts and plantings in heavy containers to narrow the turning radius and lower the pedestrian crossing distance from Poplar Street to Adams Park. The crosswalk across South Street should also be re-routed to the left to end in the existing curb ramp at Adams Park.

In addition, we think the bus stop at this location is not well sited. We observed that buses seldom pull into this stop probably because it is too short for buses to easily pull in and out. We recommend moving the bus stop west of Taft Hill Terrace to prevent potential conflicts with pedestrians.

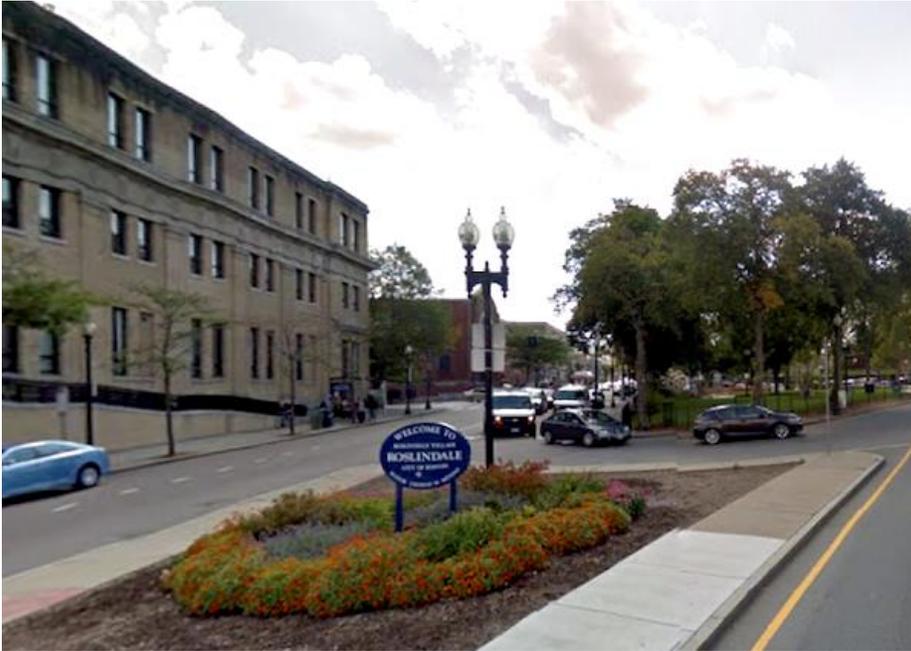
At the northeast corner of Roslindale Square across from Adams Park, there is a small triangular open space island bordered by South Street, Washington Street, and a left-turn slip lane from Washington Street onto South Street. This island has sidewalks around its edge and pedestrians use it to cross South and

Washington Streets despite the lack of crosswalks leading to it. Regardless of whether or not this open space is ultimately retained, the City needs to create a safe crossing at this location that either utilizes or circumvents the existing island.

*The triangular park at South and Washington Streets lacks safe pedestrian crossings despite having sidewalks around its border.*

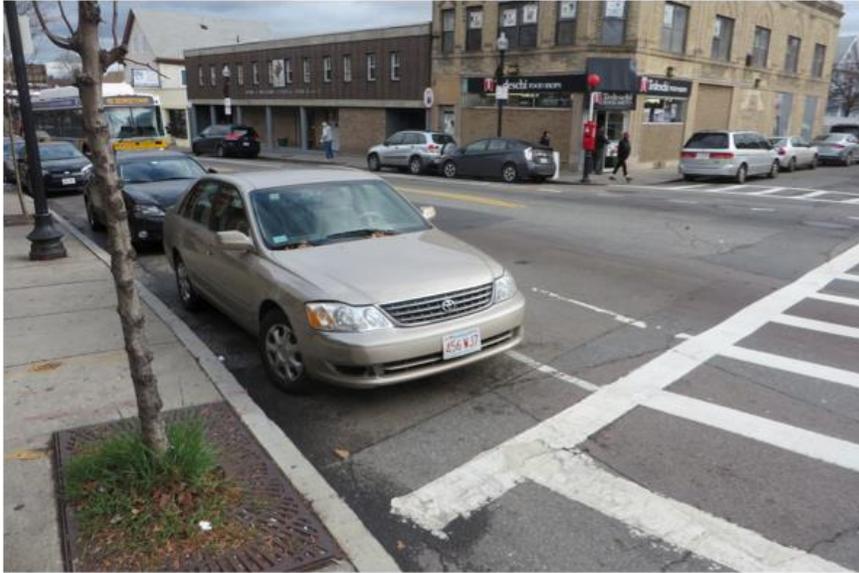
The Charles Sumner Elementary School is located half a block east of this intersection and there is a very heavy flow of walkers crossing at this unsignalized intersection. Overall, the crossing does not feel safe. Cars move quickly along the street not even stopping for the crossing guard stationed there during school opening and closing. Installing a flashing beacon or signage at this intersection to slow northbound traffic on Washington Street would create a safer pedestrian environment.

Pedestrians seeking to cross here are difficult for drivers to see. Pushing back the parking right next to the crosswalk will make pedestrians more readily visible. It is important that drivers be reminded that cars park at least 20 feet from the crosswalk as per city regulations. Moreover, the crosswalks lack handicap accessible curb cuts, creating further obstacles for those with mobility challenges. This would be an excellent location for curb extensions that would help drivers observe walkers and wheelchair users as they begin to cross.

*Cars encroach on the crosswalk at Washington/South/Basile Streets, which also lacks a curb cut.*

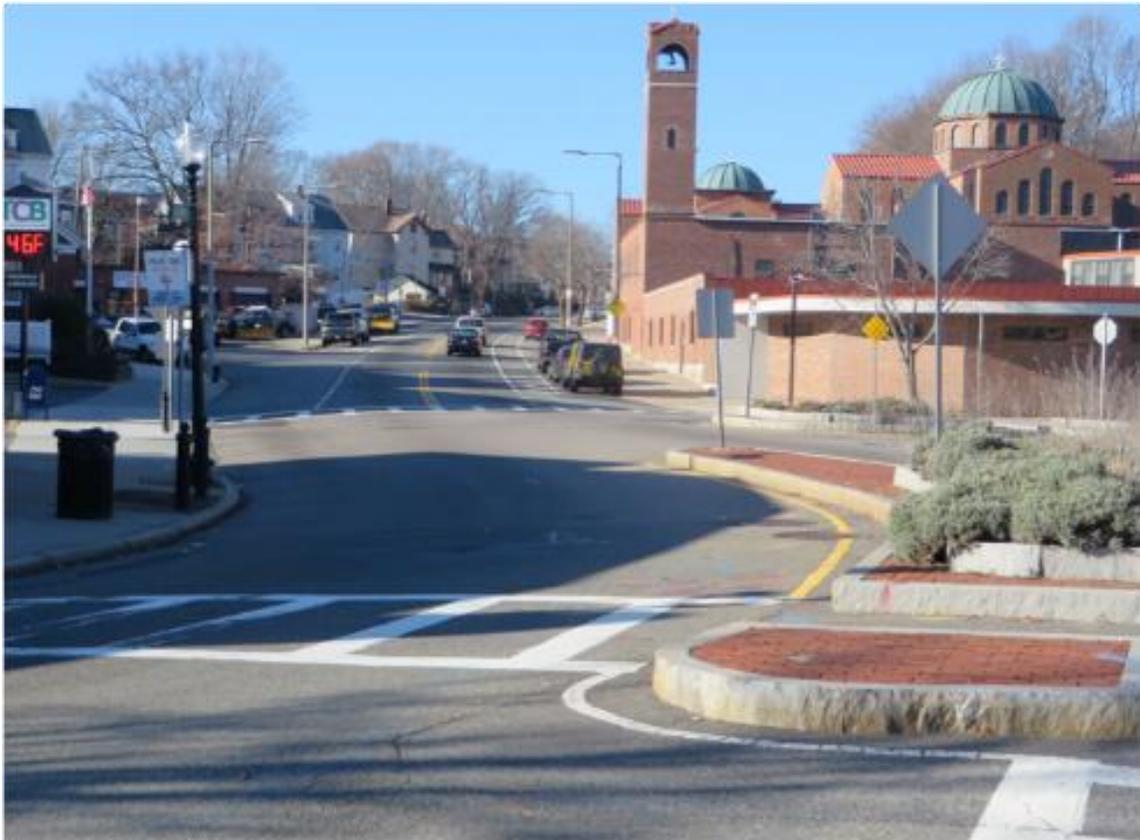
This is a confusing intersection. Eastbound traffic on Belgrade approaches Corinth at fairly high speeds because drivers are coming down a small hill. There is also a very wide right turning radius from Belgrade onto Robert Street. We recommend painting a fog line on the eastbound side of Belgrade Street to narrow the travel lane and slow traffic. We also suggest using paint and flex posts to narrow the right-turning radius at Robert Street.

*The intersection of Belgrade Avenue at Corinth and Roberts Streets is confusing to navigate, with wide travel lanes and turning radii encouraging high traffic speeds.*

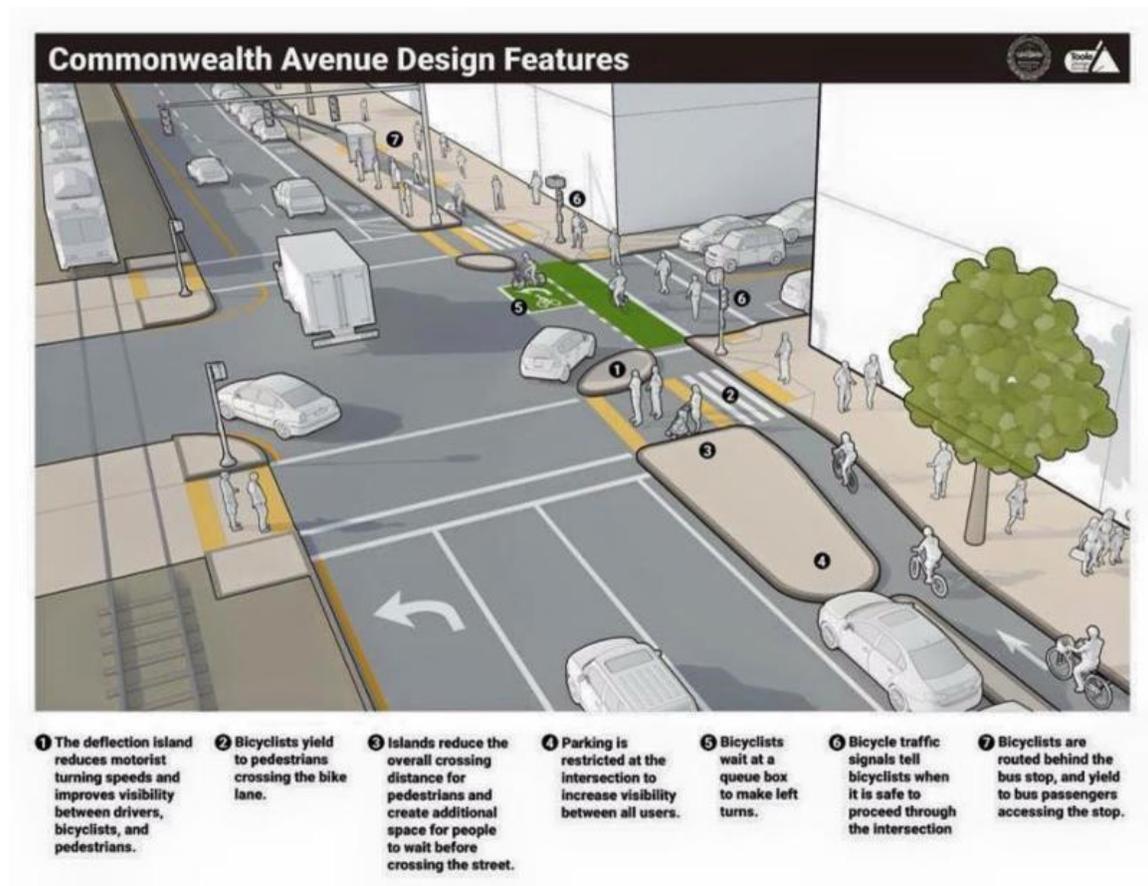
Locating bicycle lanes between parked cars and sidewalks has been shown to provide increased protection for cyclists. The diagram below, taken from the City of Boston's design for Commonwealth Avenue, illustrates the intersection layout. Bicyclists must yield to pedestrians at designated crossings. The prohibition of parking within 20 feet of the intersection and the creation of large raised platforms increase the visibility for all roadway users.
