Centre Street Walk Audit

West Roxbury Parkway Rotary to Weld Street

May 2019

West Rox Walks

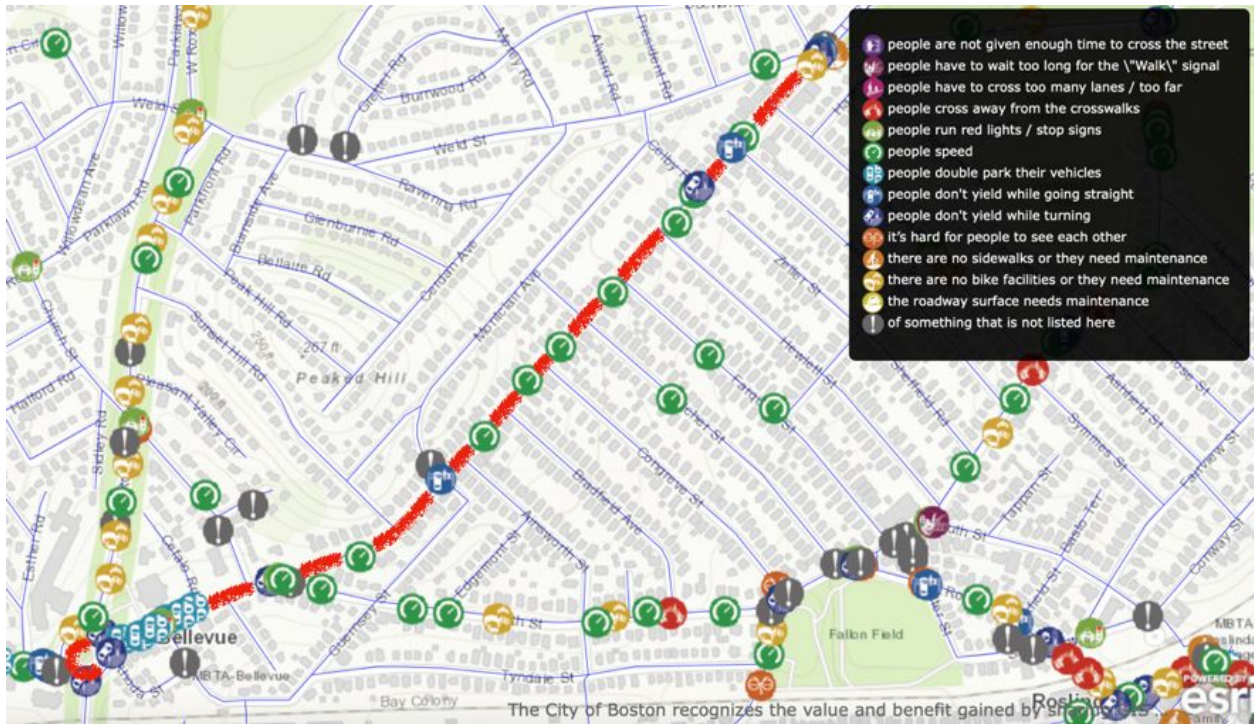
Figure 2: Vision Zero Boston Safety Concerns

Crowd-sourced map of safety concerns (Centre St. shown in red) which highlight excessive vehicle speed, failure of vehicles to yield to pedestrians, and lack of bicycle infrastructure as primary concerns along the Centre St stretch. *Source: Vision Zero Boston safety concerns map.*

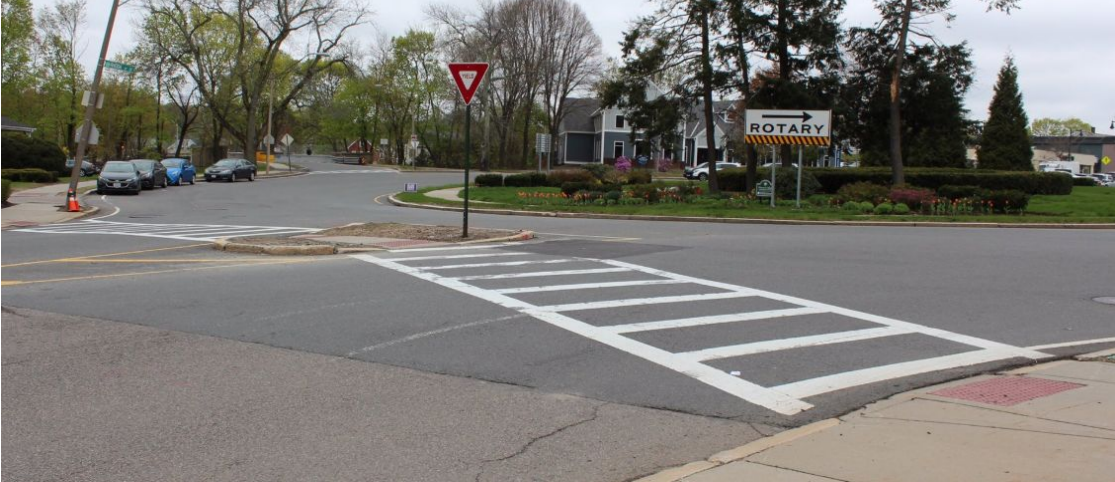
Due to the speed of traffic, multiple lanes in the rotary, and poorly marked crosswalks, the rotary is currently unsuitable for pedestrian crossing and requires significant changes. The use of RRFBs may be a simple, short-term tool to improve safety, but both vehicle traffic and pedestrian and cyclist flow require formal analysis by BTDC and WRMS in order to prevent serious pedestrian injuries and crashes.

Figure 4A: Centre St and West Roxbury Parkway Rotary

- ***Install rapid rectangular flashing beacons (RRFBs) at each crosswalk*** in the rotary and at the crosswalks at Montclair Street/Guernsey Street and at Fletcher Street. The crosswalk at Peak Hill Road is the only one on West Roxbury Parkway which is not at a traffic light and should be removed or better marked with a RRFB.

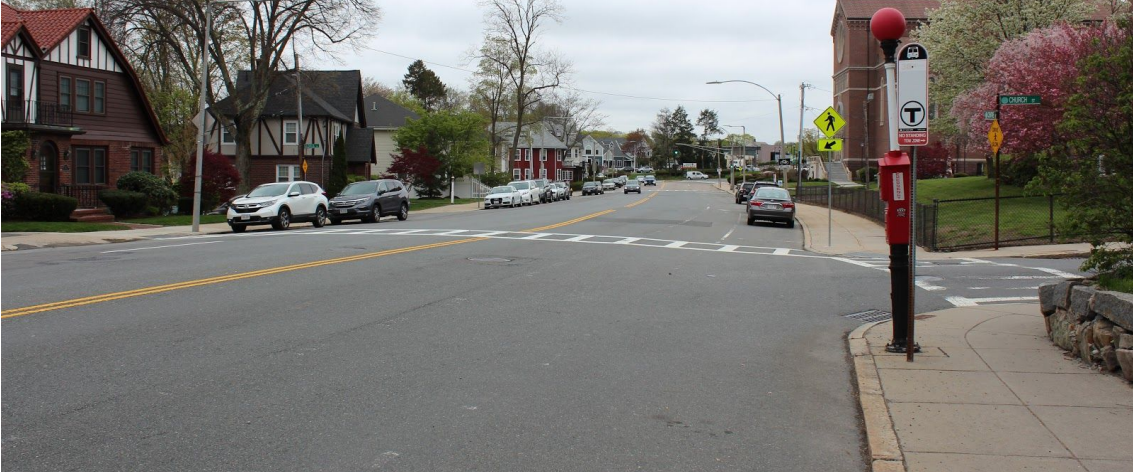
Figure 4B: Church St and Centre St opposite South St looking towards the Centre/West Rox Pkwy rotary

- **Limit passthrough traffic on Church Street and remove the crosswalk.** Commuters should not be allowed to drive through these new conduits that route traffic around the rotary. Consider additional signage that reflects driving restrictions through Church Street. Additionally, the crosswalk across Centre Street at Church Street is unsafe and should be either be enhanced with a flexpost island, an RRFB, or eliminated because it must cross three lanes of traffic. If removed, pedestrians can cross Centre at the South Street or Colbert Street intersections.

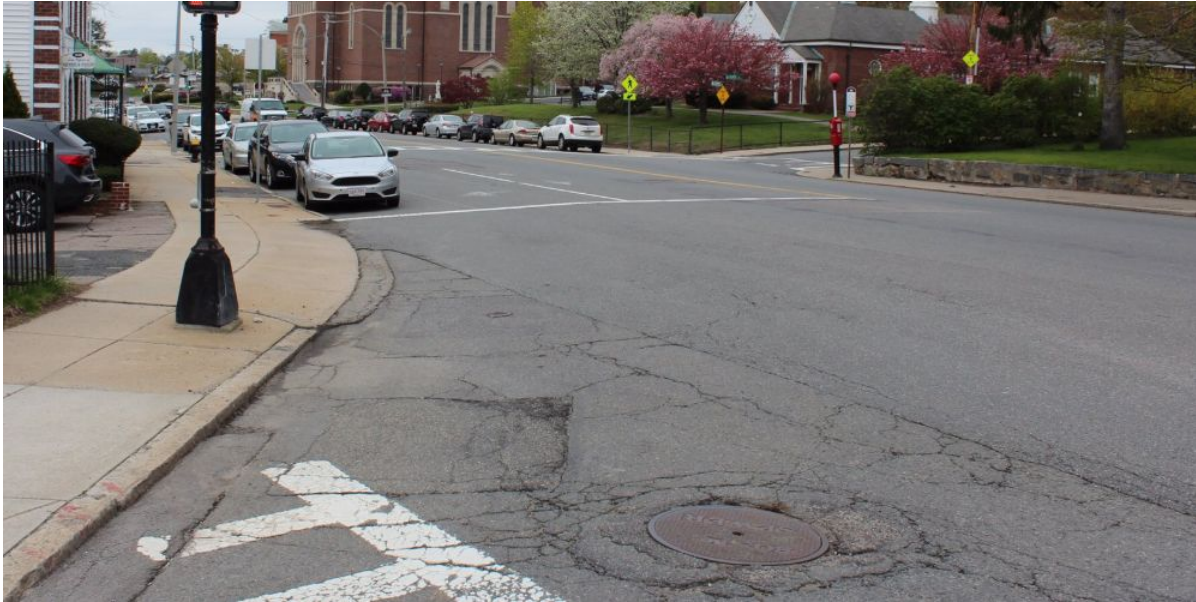
Figure 4C: South and Centre St looking toward Centre and Church St.

- ***Improve crosswalk signals and timing.*** The crosswalk signal at Colbert Street is too short for pedestrians. The length of the walk signal should be increased to help cross this wide street (i.e. > 50 feet). A concurrent traffic signal that stops right-turning traffic briefly at South Street is also needed.

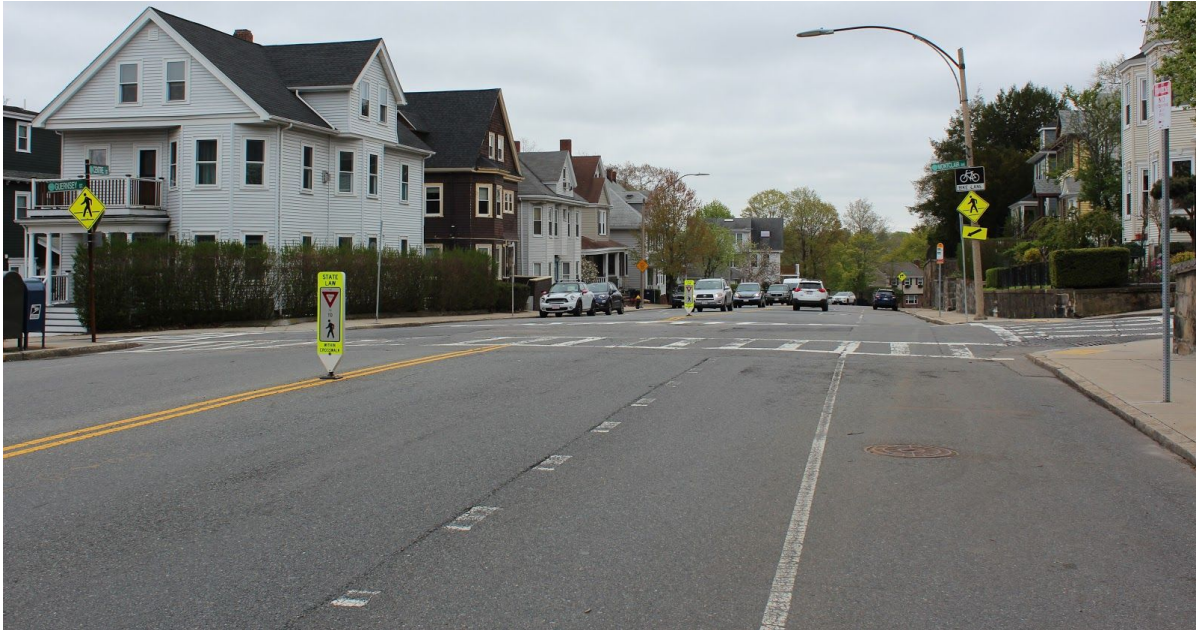
crosswalks will also help improve visibility. Currently, bus stops like Montclair/Centre are to the right of pedestrians as they enter crosswalks, while parked cars to the left limit the visibility of the pedestrian to oncoming traffic.

Figure 4D: Guernsey (left) & Montclair (right) from Centre St.

- **Install curb extensions and flexpost islands** for crossing at Montclair Street/Guernsey Street and at Fletcher Street.
- **Review the location of pedestrian crossing signs** at all intersections. At Montclair Street/Guernsey and Ardale, the location of the signs does not effectively communicate the need to drive cautiously at crosswalks.

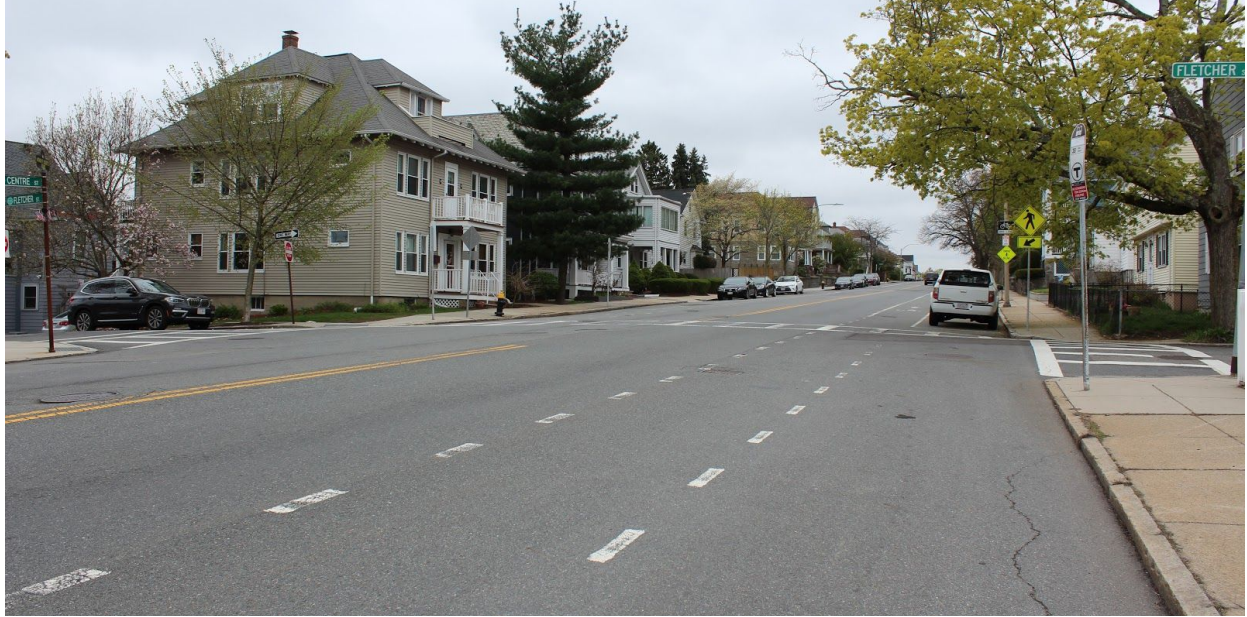
Figure 4E: Fletcher and Centre intersection looking south-westbound on Centre.

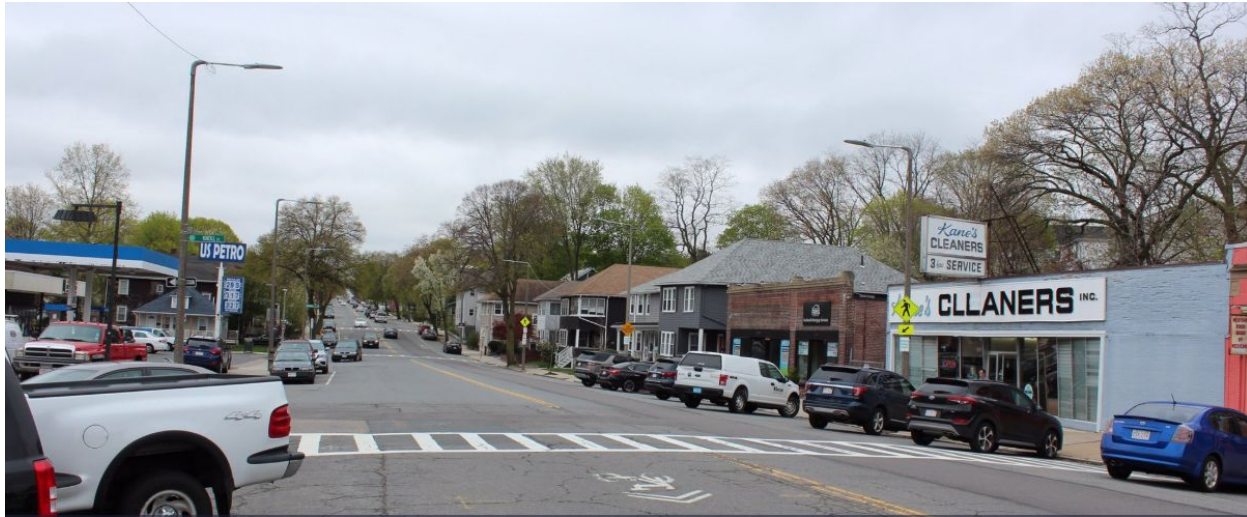
The section of Centre Street between Knoll and Weld Streets has the potential to connect adjacent West Roxbury and Roslindale neighborhoods to a lively business district and to the Arnold Arboretum. Current challenges include poor visibility at Knoll Street due to adjacent angled parked cars, lack of a bike lane, merging of the street's vehicle traffic from two lanes to one, and the high speed of car traffic traveling from Jamaica Plain into West Roxbury. The complexity of these problems warrants further study by BTM and WRMS to increase the safety and economic success of this business district.

Figure 4F: Centre St at Knoll, looking south-west on Centre St.
