Cummins Missing Middle Virtual Walk Assessment

Released 15 JUNE 2021

1. Introduction

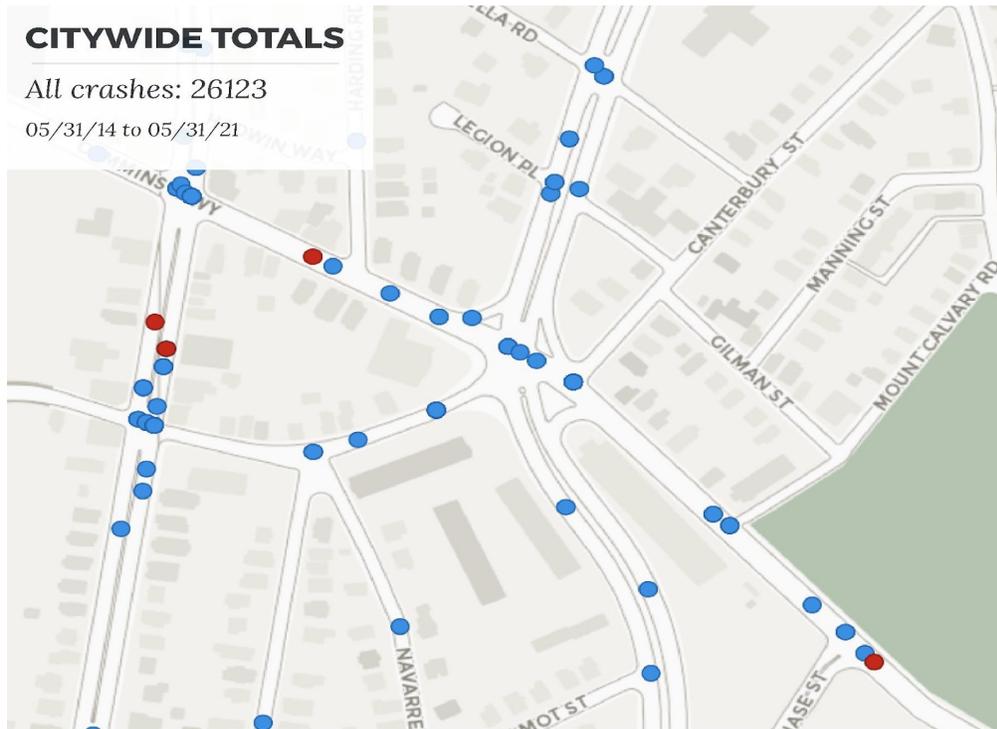
Figure 2 - Central Study Area Crash Map

The Octopus is also a residential neighborhood connector, yet it is on the map of the top 3% of serious crash intersections in Boston. As stated above, about two thousand residents live within a short distance to this intersection, but few dare to walk or bike. The lack of safety and comfort forces most of us, who can, to drive, adding to the problem. Many seniors live in this area. They get very isolated, especially in the winter as they don't feel safe walking to stores or bus stops, there is insufficient plowing, and there are no bus shelters as windbreaks and to sit in.

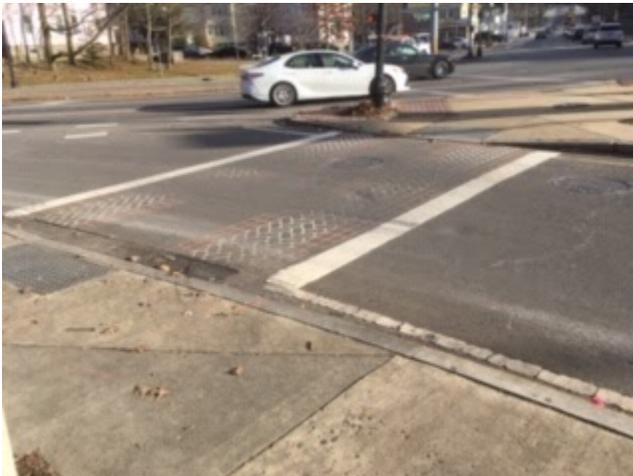
Photo 1 - Typical slip lane at the Octopus.

There are three slip lanes. Motor vehicle operators driving north on Cummins can avoid the traffic light and ramp on the right onto American Legion, without having to stop or barely slow down. Cars driving from Hyde Park east on American Legion can avoid the

traffic light and ramp to the right to get onto Cummins. And those driving west on American Legion can avoid the light and ramp onto Cummins going towards Roslindale Square. There are crosswalks across each slip lane but drivers never slow down for pedestrians - they are looking ahead and to the left to gauge when there will be a break in the traffic for them to accelerate onto the cross street. The slip lanes support the flow of motor vehicle traffic but are an obvious and avoidable hazard to pedestrians and cyclists. Like so many intersections around the city, the main American Legion/Cummins intersection used to have tight turning angles closer to 90 degrees, until the city "improved" it (for increased car volume) after the Second World War. It should be noted that those "improvements" privileged convenience over safety for drivers, too. Those plans also showed how they narrowed the previously ample sidewalks, in the intersection and also along American Legion Highway past the shopping centers east and west of the intersection.

- Continue the protected cycling lanes on Cummins (coming over from Wood/Harvard) and American Legion (coming down from Walk Hill) through this intersection.
- Eliminate all slip lanes.
- Create extra protection and extensions around crosswalks and corners with concrete barriers and flexposts to daylight intersections, reduce the curb radius

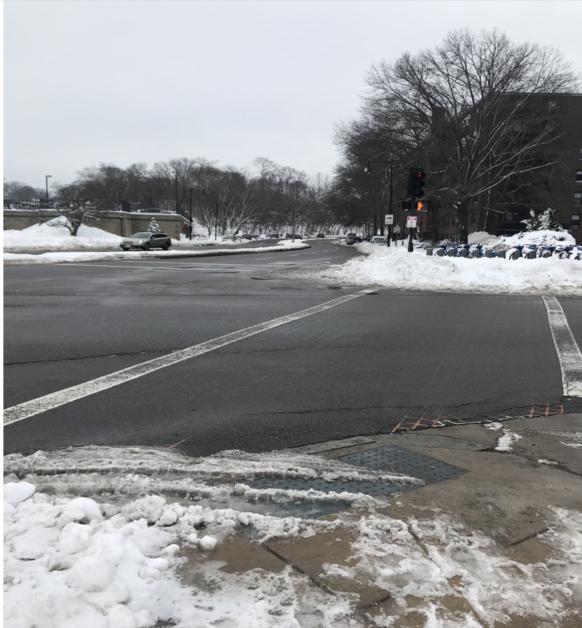
Photo 2 - Plowed in pedestrian refuge island at the Octopus.

There are four pedestrian refuges, one large and three small ones, between the main lanes and the slip lanes. They are essential, but inadequate - the small ones in particular still leave one feeling very exposed to the fast-moving traffic on both sides. Many participants noted that several days after a 12 in. snowstorm in early December, the city had still not plowed any of the pedestrian refuges. In fact, there were three-foot mounds of packed snow around each refuge from the plowing done to clear the vehicle lanes. None of the bus stops were plowed. Nearly all of the curb ramps had been plowed over and not cleared out.

wherever possible, and install yellow truncated dome pads at all ramp to assist pedestrians with visual and mobility impairments.

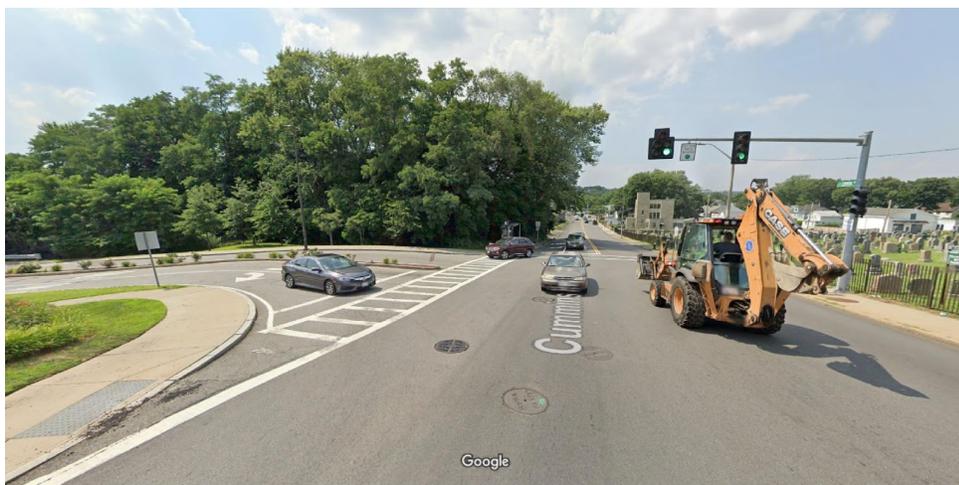
Photo 3 - Cummins at the Stop & Shop Entrance

This intersection is a main access point for hundreds of shoppers weekly who frequent the Stop & Shop, Walgreens, the local bank and the gym, among other businesses. Participants reported that drivers leaving the plaza and turning left onto Cummins Highway rarely stop for pedestrians walking across Cummins Highway (The walk signal is unfortunately concurrent with left-turning traffic. Drivers on Cummins northbound turning left to enter the plaza rarely stop for pedestrians crossing the entrance, drivers leaving the plaza turning left onto Cummins rarely stop for pedestrians crossing Cummins, and drivers turning right on red into the plaza often roll through the intersection without bothering to stop. Very few drivers pay attention to pedestrians in the crosswalks. There are no trash cans, including at the one bus shelter.

- Implement an exclusive pedestrian signal instead of concurrent signaling.
- Install yield signs and enhanced lighting at night.
- Require consistent snow removal (especially on the Hyde Park side towards the bus shelter).
- Continue bike infrastructure and sidewalks inside the plaza.
- Move the MBTA Route 30 bus stop from in front of the driveway to behind it to save pedestrians from having to cross the driveway.
- Install a bus shelter for the bus stop on the Mt. Calvary Cemetery side of Cummins.
- The right turn into the plaza needs to be “No Turn on Red.”

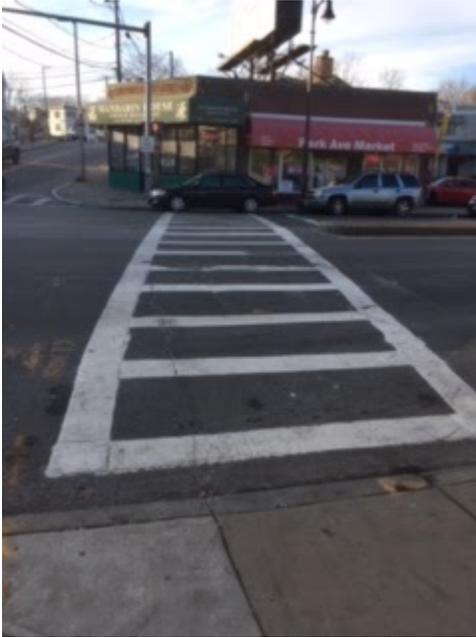
Participants noted that cars tend to accelerate through this intersection, paying attention to other cars rather than pedestrians. They also found the sidewalks to be

uncomfortably narrow and lacking tree coverage, as well as difficult to navigate due to inconsistent snow removal. Cars often park too close to corners or in crosswalks and crossing Hyde Park Avenue is daunting, especially considering the lack of protection at the center of the long crosswalks, where a protected pedestrian refuge is completely missing. One participant reported that walking across the large curb cut at the fire station felt “extremely exposed.”

- Add additional signage for no parking zones.
- Repair and level sidewalks.
- Install pedestrian protection at medians at crosswalks.
- Install barriers/posts to help with daylighting, and tactile yellow truncated dome pads on curb cuts.
